Manhole Inspection Summary

Manhole # S2500_010MH

Location Address: **914 CHAUNCEY AVE**

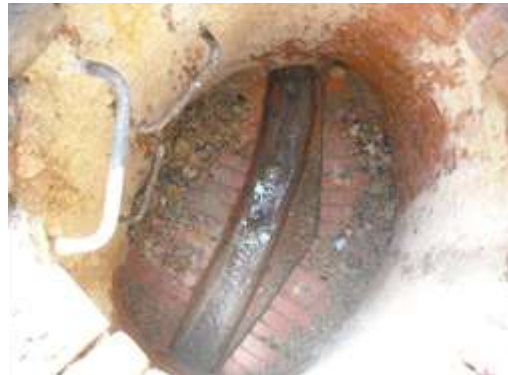
Top View

Bench debris.

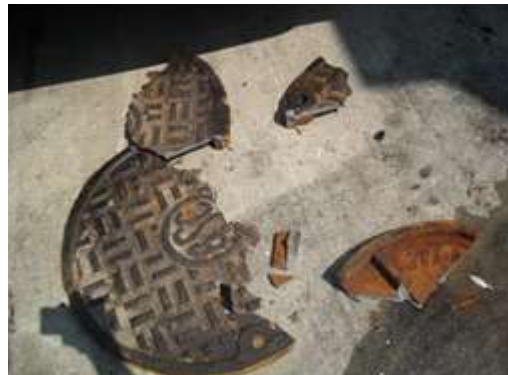
Broken lid

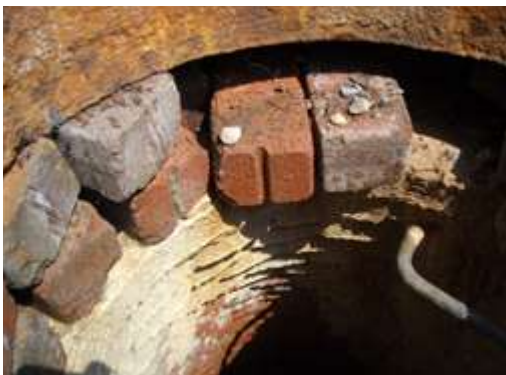
Defect

Frame offset. Adjustment deterioration, loose brick and infiltration.

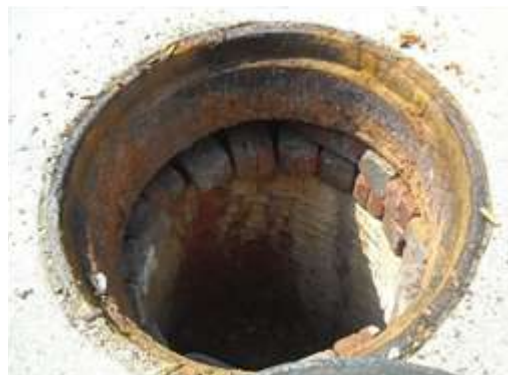
Defect

Frame offset. Adjustment deterioration, loose brick and infiltration. Barrel infiltration.
